Link Manufacturing, Ltd.

TECHNICAL SERVICE BULLETIN

Self-Steer Auxiliary Suspensions

Subject: Recommended Service Inspection

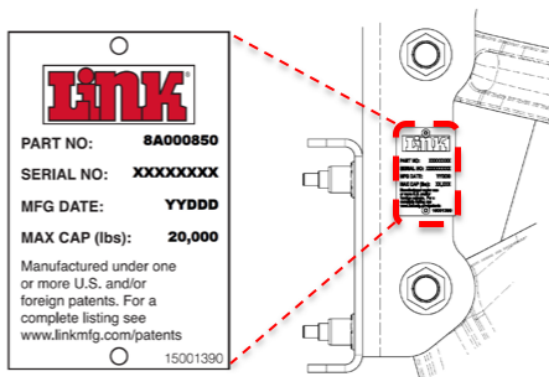
The suspension identification ID tag is located on the driver's side front hanger bracket as shown below.

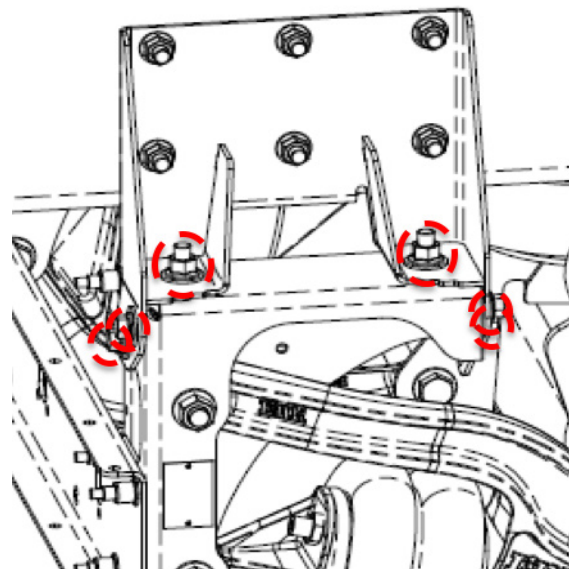
Figure 1

6 washers should be installed in the Hanger Bracket to Frame Bracket fasteners on Each Side of suspension.
(Washer locations can be seen highlighted in red)

Link Manufacturing has become aware of a possible issue with certain self-steer auxiliary suspensions. In a limited number of applications in the field, some fastener joints have worked loose, allowing the connections to move. If this condition is not corrected, cracks may develop in the frame brackets or the suspension hanger bracket which may eventually have an adverse effect on the function of the suspension. As a result, Link recently began manufacturing suspensions using hardened washers in the hanger bracket to frame bracket fastener joints. Link recommends washer kits be installed on all pre-identified suspensions in the field. Washer locations are shown in (Figure 1)

*Please call Link Customer Service at 800-222-6283 to arrange shipment of Link's washer kit (part #4AS00103) prior to the scheduled service to help reduce down time. Also call Link if any replacement parts are needed during service inspection.

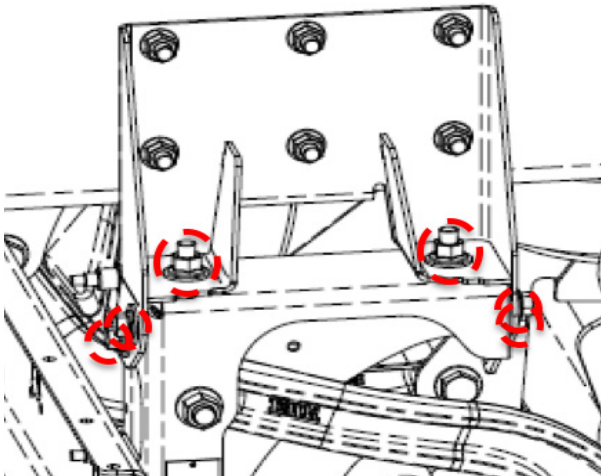
Figure 2

Check 6 Hanger Bracket fasteners on each side for proper torque and that washers are installed. Make sure to follow torque sequence shown in washer kit part #4AS00103 installation instructions.

Torque Value: 220 ft. lbs.

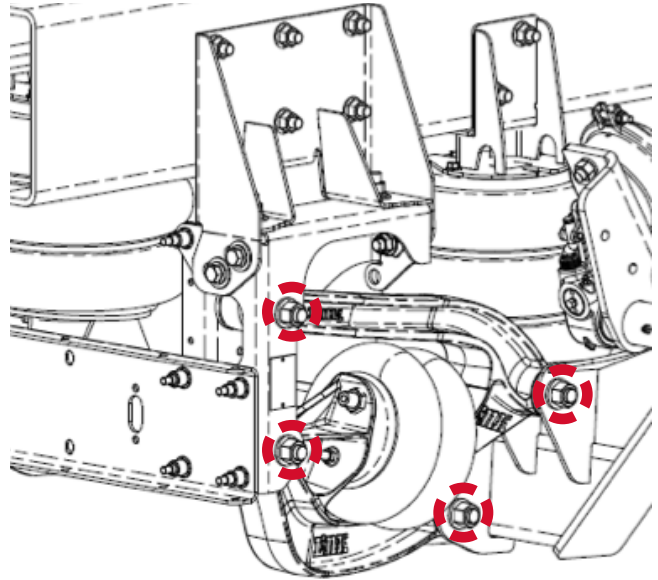
Figure 4

Check 4 Arm fasteners on each side.

Torque Value: 350 ft. lbs.

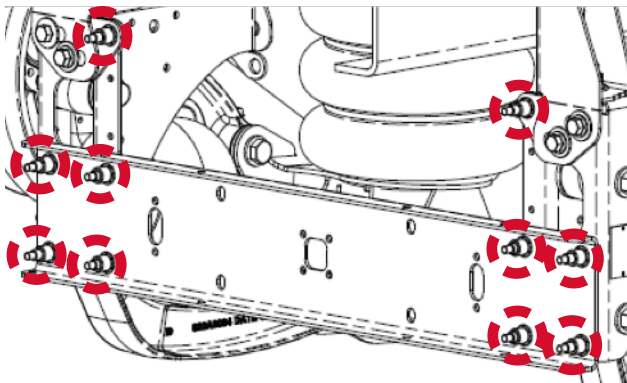
Figure 3

Check the 10 Huck fasteners shown below to see if they are loose or if there are signs of wear in the paint around the Huck fasteners.

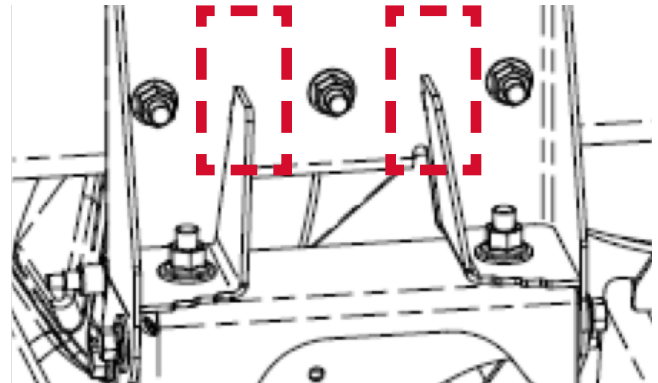
Figure 5

Check the Front Frame Bracket on each side for cracks in the areas shown below.

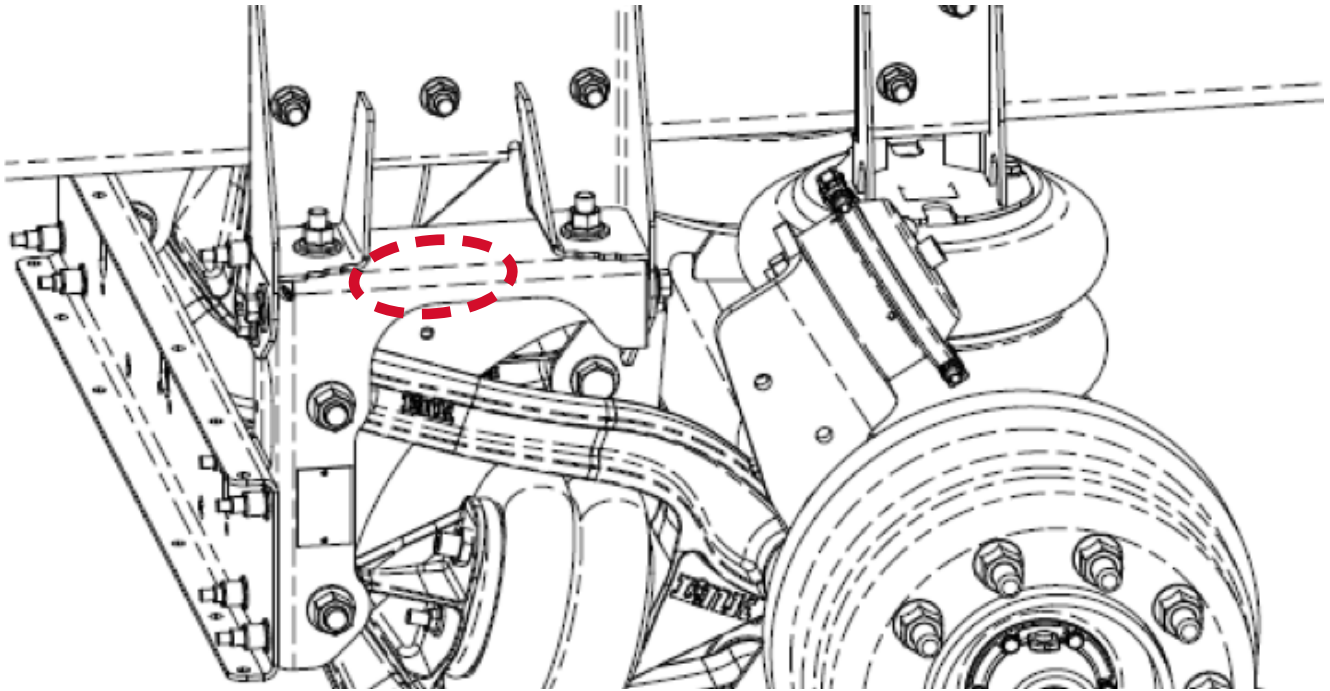
Figure 6

Check the Front Hanger Bracket on each side for cracks in the area shown below.

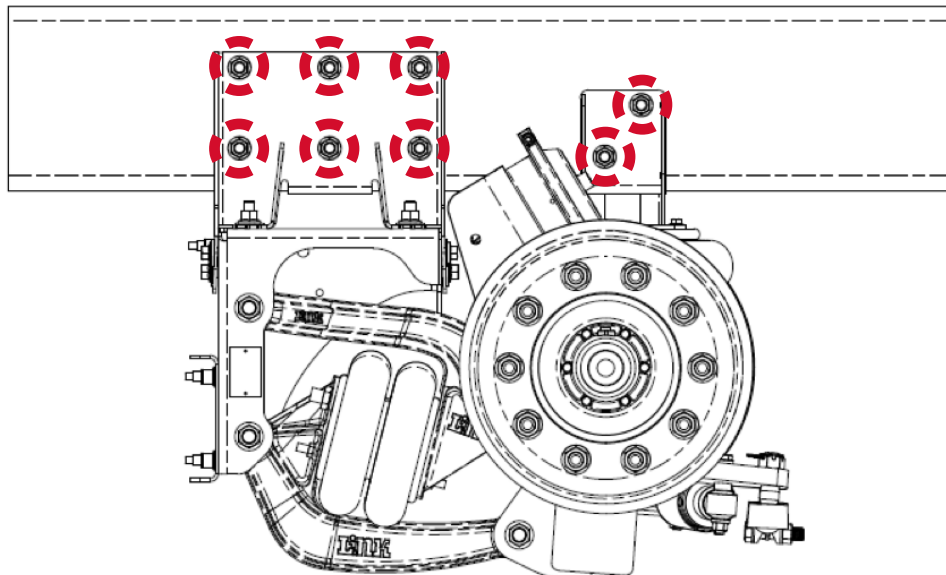
Figure 7

Check 8 Frame Bracket fasteners on each side. **Torque Value:** 220 ft. lbs.
