CABMATE MODEL: OKTP Oshkosh P-Series (27602200)

CABMATE MODEL 27602200

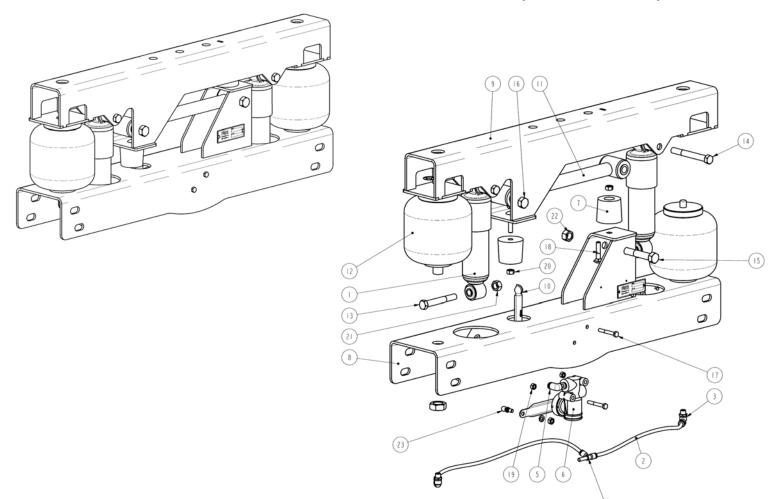
ITEM	PART #	DESCRIPTION	QTY	ITEM	PART #	DESCRIPTION	QTY
1	12010054	SHOCK ABSORBER	2	13	1403-1426	7/16 X 3 1/4 UNF HEX CAP SCR (GR 5)	2
2	13020090	AIRLINE-NYLON, 1/4" BULK (FEET)	2.5	14	1403-1430	7/16 X 3 3/4 UNF HEX CAP SCR (GR 5)	2
3	13025203	ELBOW, 1/4 TB 1/8 M-NPT	2	15	1404-1624	1/2 X 3 UNF HEX CAP SCR (GR 8)	1
4	13025497	RUN TEE, 1/4 TB 1/4 PTC, PUSH-IN DOT	1	16	1404-1630	1/2 X 3 3/4 UNF HEX CAP SCR (GR 8)	1
5	13025499	ELBOW-PLUG-IN, 1/4"	1	17	1405-0609	HEX CAP SCREW, M6 X 1 X 45, CLASS 8.8	2
6	13500102	SERVICE KIT-HEIGHT CONTROL VALVE	1	18	1435-1012	5/16 X 1 1/2 UNC RND HD SQ NK BOLT (GR 5)	2
7	15000070	BUMPER-JOUNCE, 1.75	2	19	1476-0607	HEX TOP LOCK NUT, M6 X 1, CLASS 8	2
8	27601015	BRACKET-MOUNT, CROSSMEMBER	1	20	1476-1000	5/16 UNC HEX CTR LOCK NUT (GR B)	2
9	27601016	BRACKET-MOUNT, CAB	1	21	1477-1400	7/16 UNF HEX CTR LOCK NUT (GR B)	4
10	29910052	KIT-LINKAGE, LONG	1	22	1477-1601	1/2 UNF HEX TOP LOCK NUT (GR C)	2

11	29934001	LATERAL CONTROL ROD	1	23	2991-0026	SERVICE KIT-PIVOT BALL	2
12	1102A047	AIR SPRING WITH ATTACHMENTS	2	·

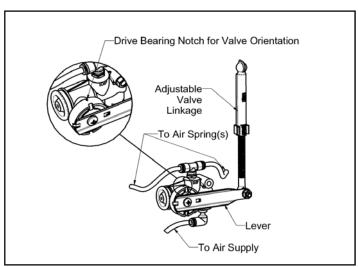
HEIGHT ADJUSTMENTS

Measure the design height of the air spring(s). The height should be 5 3/4 inches ± 1/16. To change the height, disconnect one end of the valve linkage and adjust accordingly. Tighten the lock nuts on the valve linkage.
